Specific Structural Inspection Plus Drone Images

11 May 2023

Report undertaken by Andrew Parker AssocRICS, MCIOB
On behalf of Drone Building Inspection & Surveying Services Ltd
Job number Dbiss00416

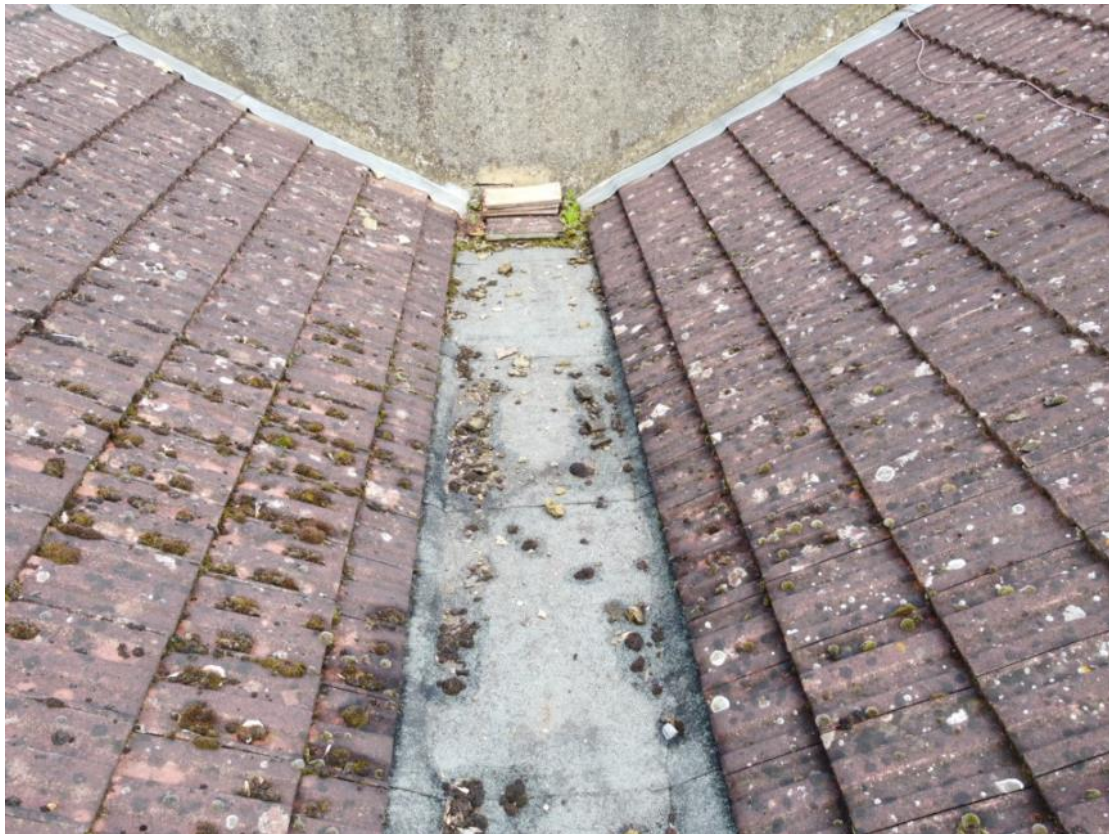
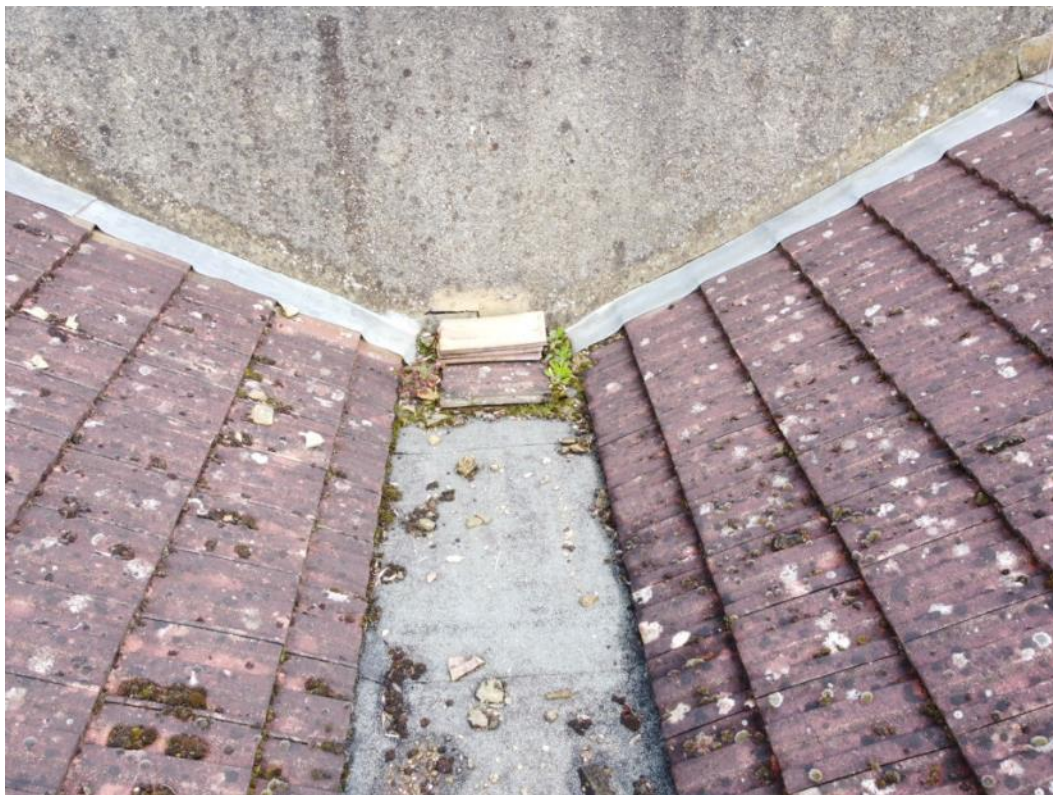
The valley gutter to the main roof has been recovered historically with mineral felt. This is not as long lasting a lead, although appears to currently serviceable and free from extensive previous repairs. There is some defective and crumbling render to the base of the parapet wall, over the gutter and it is likely this is the cause of the moisture ingress and damaged timber seen within the left hand roof void to the main building.

Defective render to base of parapet appears to be leading to moisture ingress

I recommend any defective render here is repaired and replaced and then the timber repairs carried out, as suggested in the previous report.

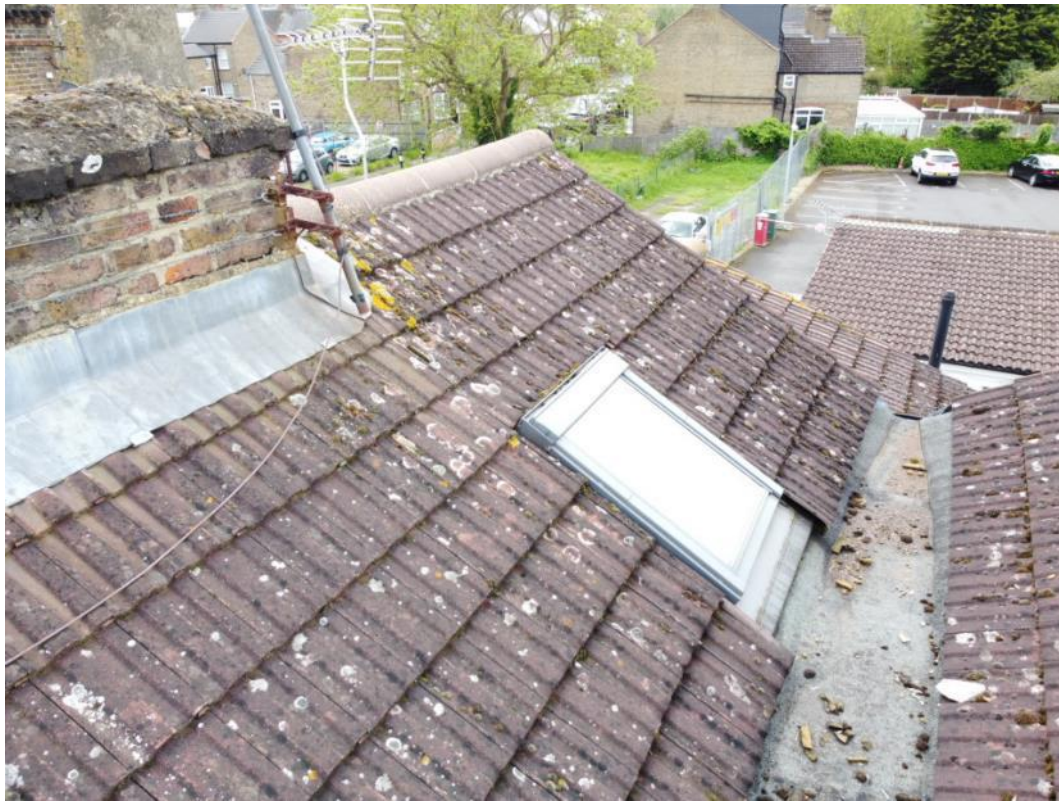
V- Lux style window appears to be blocked up from the inside
